LAKE KAL-TATRI
STE. GENEVIEVE COUNTY, MISSOURI

MISSOURI INVENTORY NO. 31039

PHASE I INSPECTION REPORT
NATIONAL DAM SAFETY PROGRAM

SEPTEMBER 1978

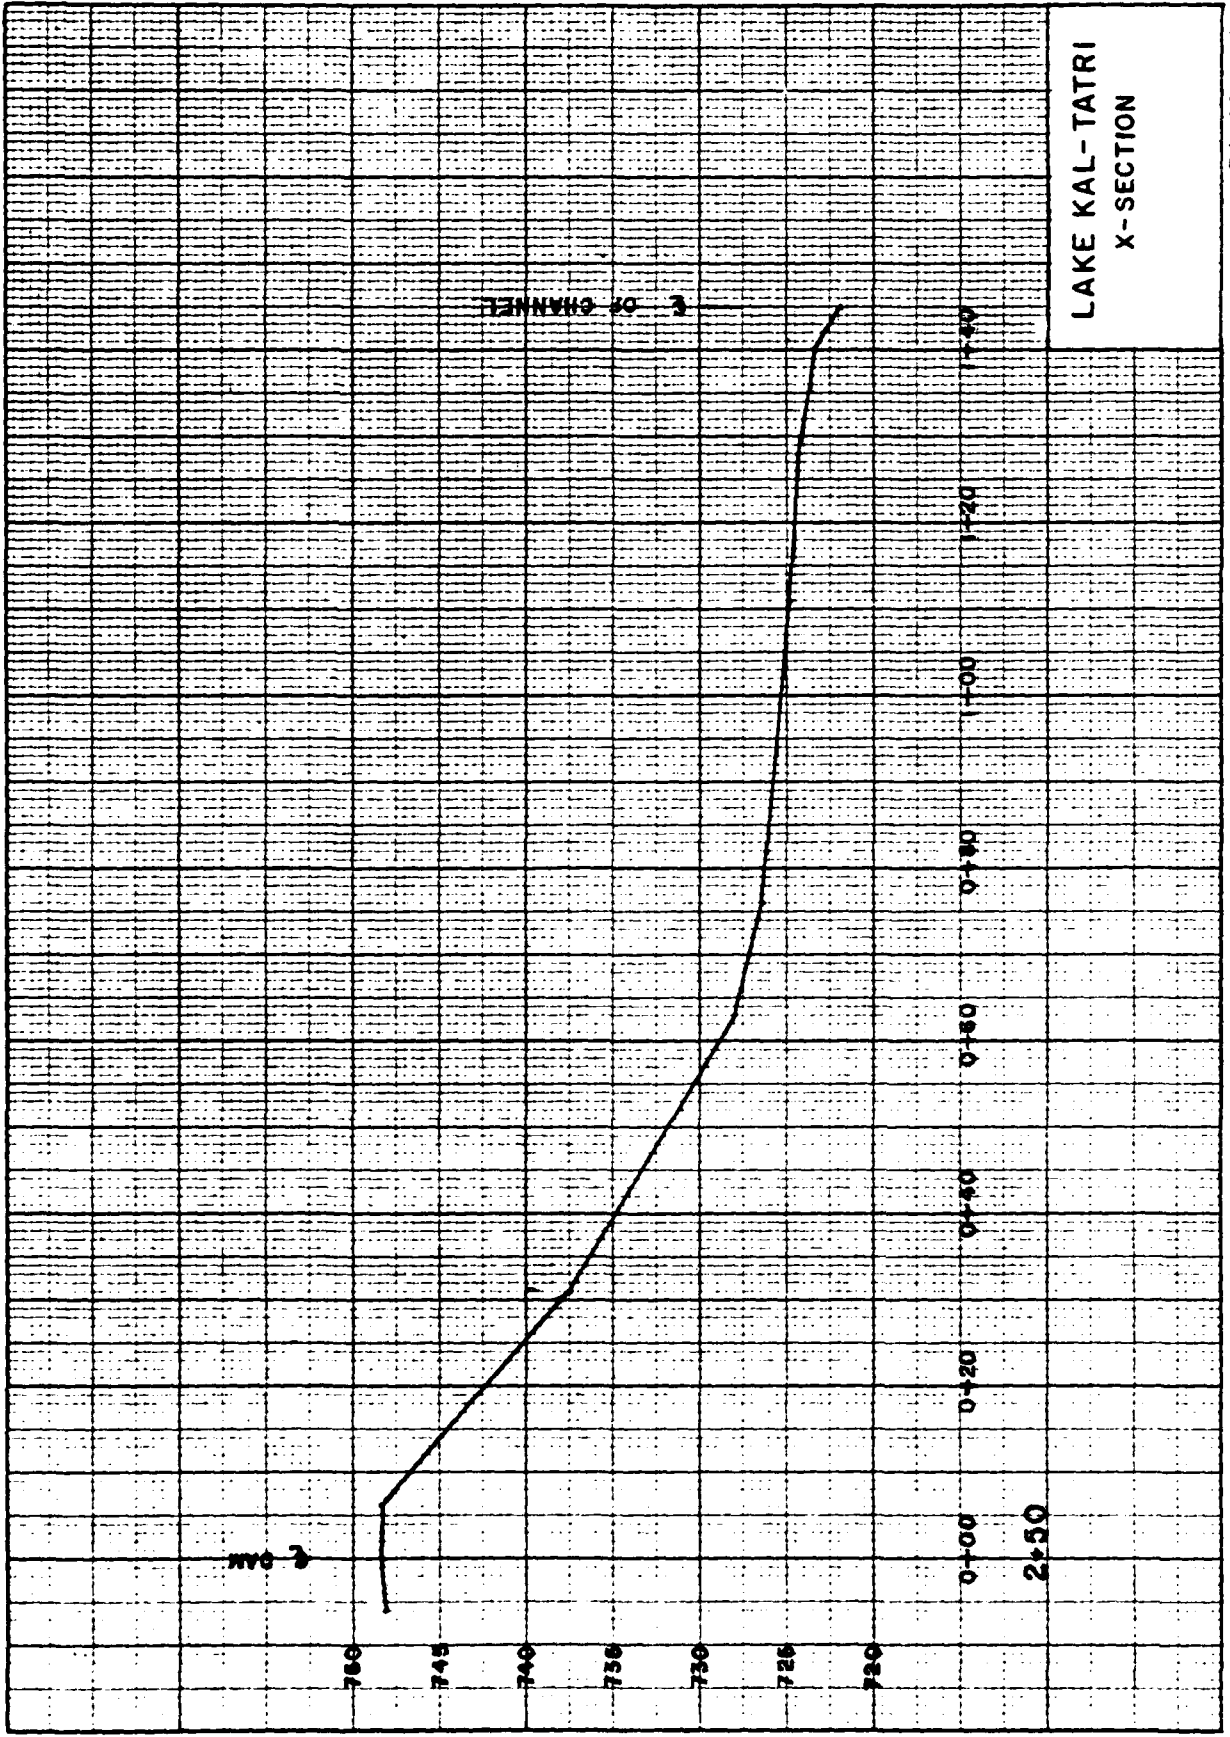
A typical embankment cross section is shown on PLATE 2. The 1V on 2.5H side slopes appear adequate for a dam of this height constructed from these materials. Tall weeds and light brush were present on the downstream slope. A number of small pine trees on the downstream slope had recently been cut and were laying on the slope. No large trees were present in the embankment except for one isolated group at the toe near the left abutment where the dam is very low.

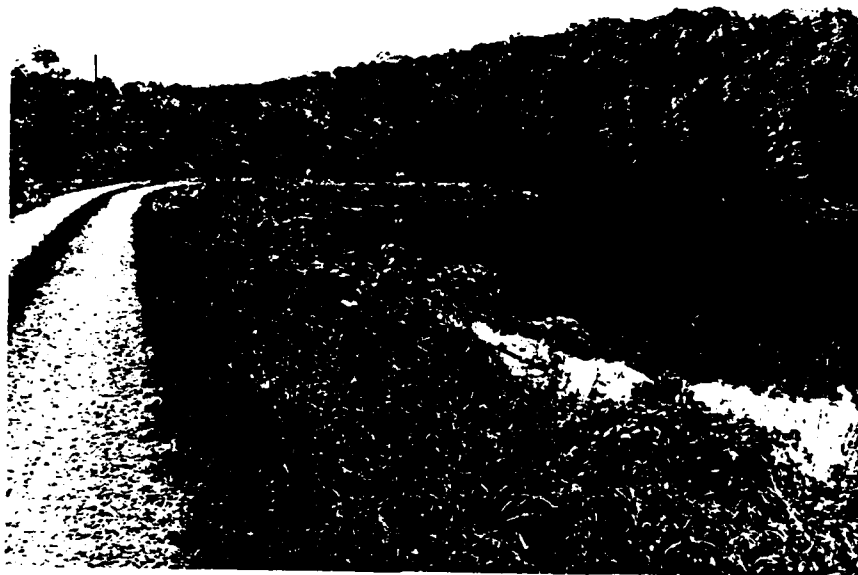
The upstream slope of the dam had been covered with light brush but had recently been cleared. Cut brush was piled along the slope. Scattered sandstone boulders were present on the upstream face. Good engineering practice would be to provide adequately sized, graded riprap for wave protection; however, the very short fetch and hilly terrain around the lake minimize the likelihood of wave damage to the embankment.

No. 1 UPSTREAM FACE

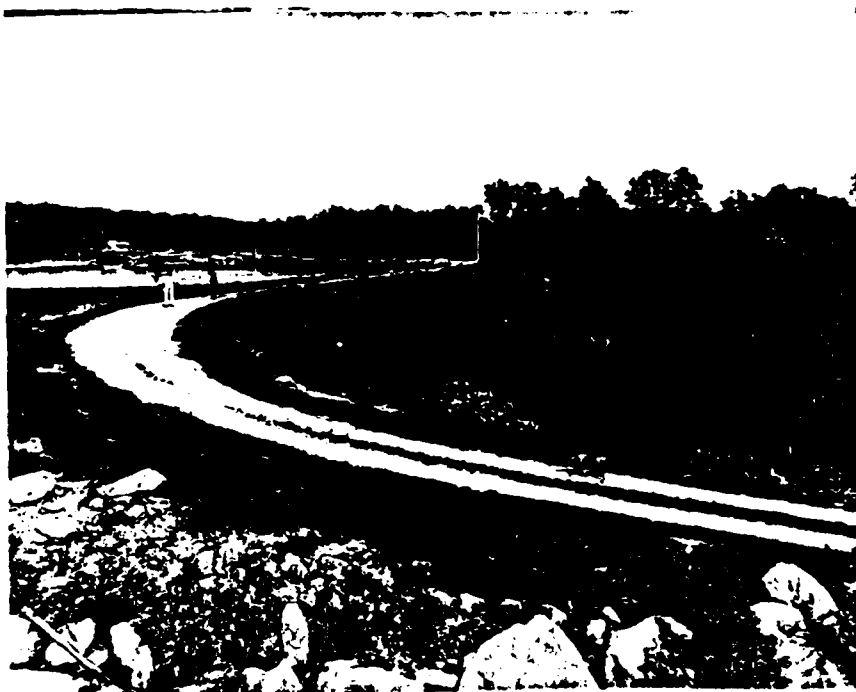
NO. 5 DOWNSTREAM SLOPE

c. Remove brush on dam slopes.

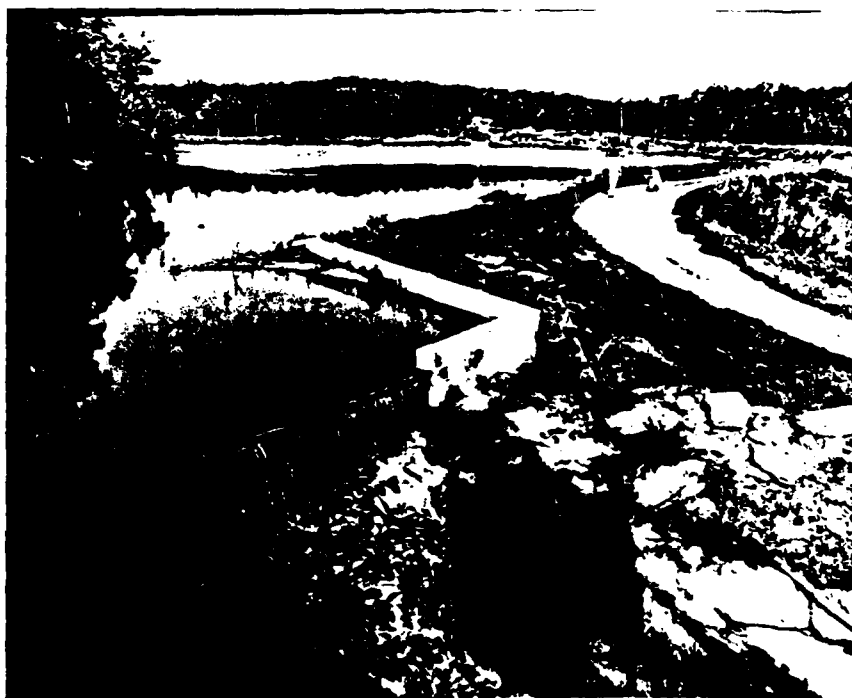
d. Appurtenant Structures. A concrete spillway is located on rock at the right abutment. The spillway consists of a vertical concrete wall with a notched weir. A partial concrete approach apron is provided upstream of the weir. The concrete was in good condition.

NO. 6 SPILLWAY

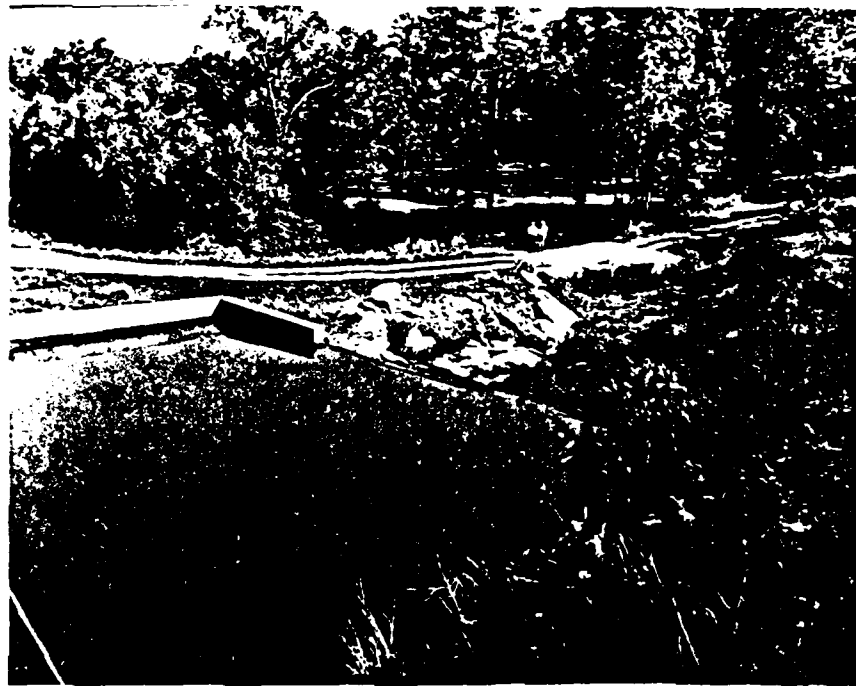
(4) Located downstream of the dam is a small concrete bridge with three 27-inch corrugated metal pipes. The bridge had no rails and appeared to be constructed as an overflow bridge. The bridge will have no hydraulic effect on the performance of the spillway. (See photographs 2, 3, and 7.)

NO. 7 SPILLWAY
